# Perseverance Creek Flood Risk Assessment

## Options Analysis and Class 1 Risk Assessment

Final Report, Rev. 1

#### **Village of Cumberland**

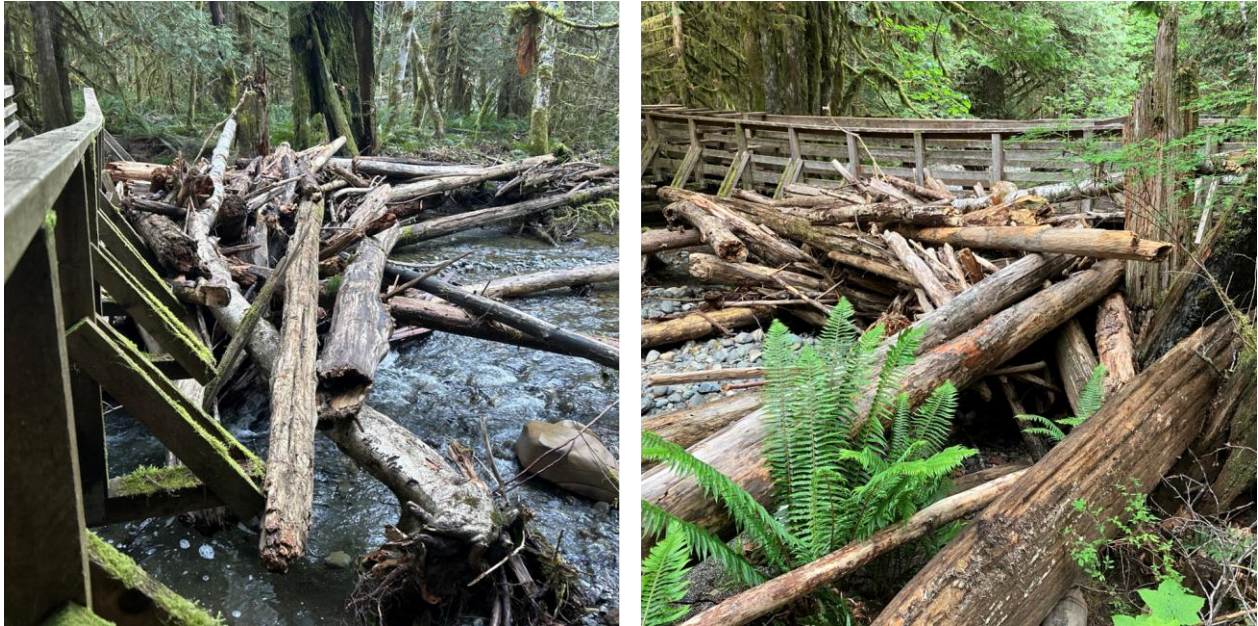
In the short-term, NHC recommends removing the trail bridge and log jam to reduce the chance of an outburst-type event potentially causing damage to the well and associated linear infrastructure, as well as posing a Risk to public safety in the area. This may carry an increased Risk of surface water flooding this winter during low and medium flows, but the amount of damage from an outburst type event is more uncertain and potentially more severe. We have therefore assigned it a greater Risk.

**Figure 1.1** Looking at log jam on upstream side of Hai Gai trail bridge. Left photo taken from river left on April 7, 2026. Right photo taken from river right on June 10, 2026.

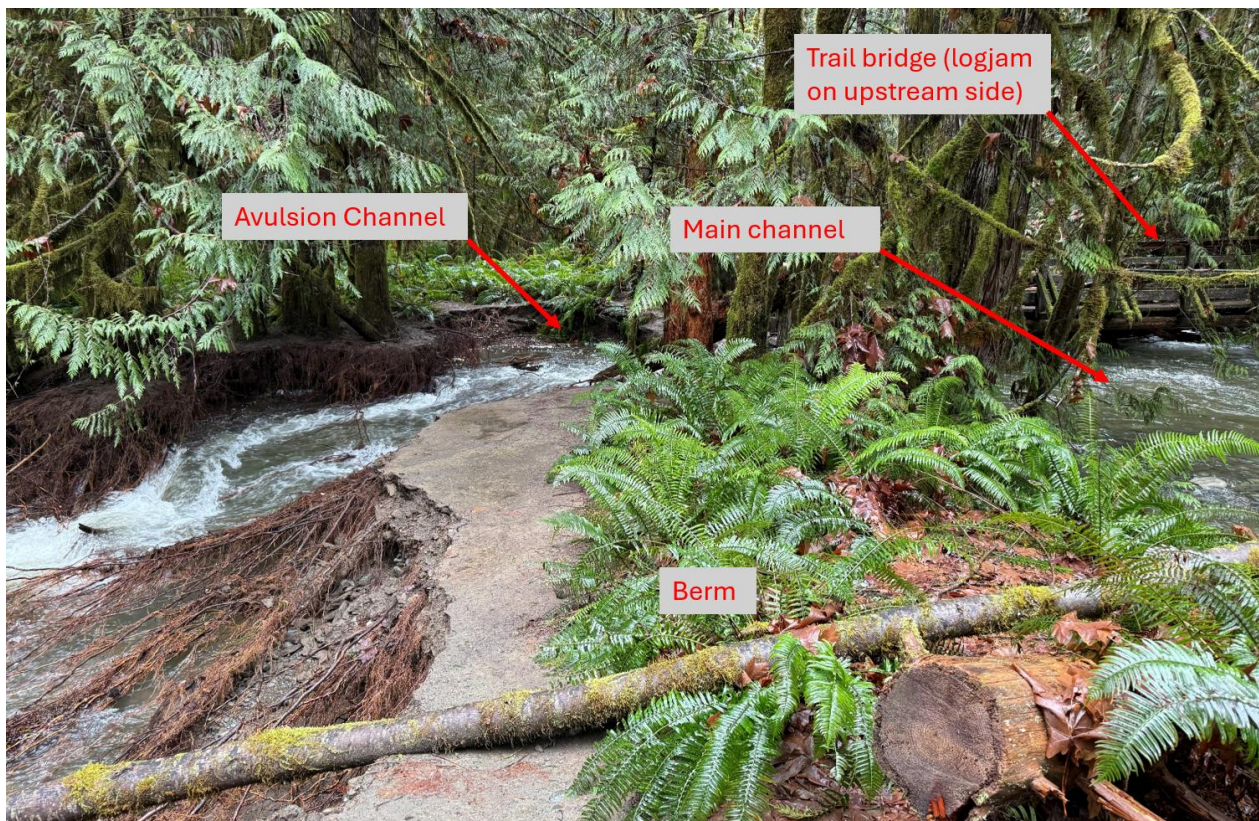
**Figure 1.2** Looking upstream at avulsion channel and Perseverance Creek main channel on February 1, 2026. Photo courtesy of Adam Silverstein.

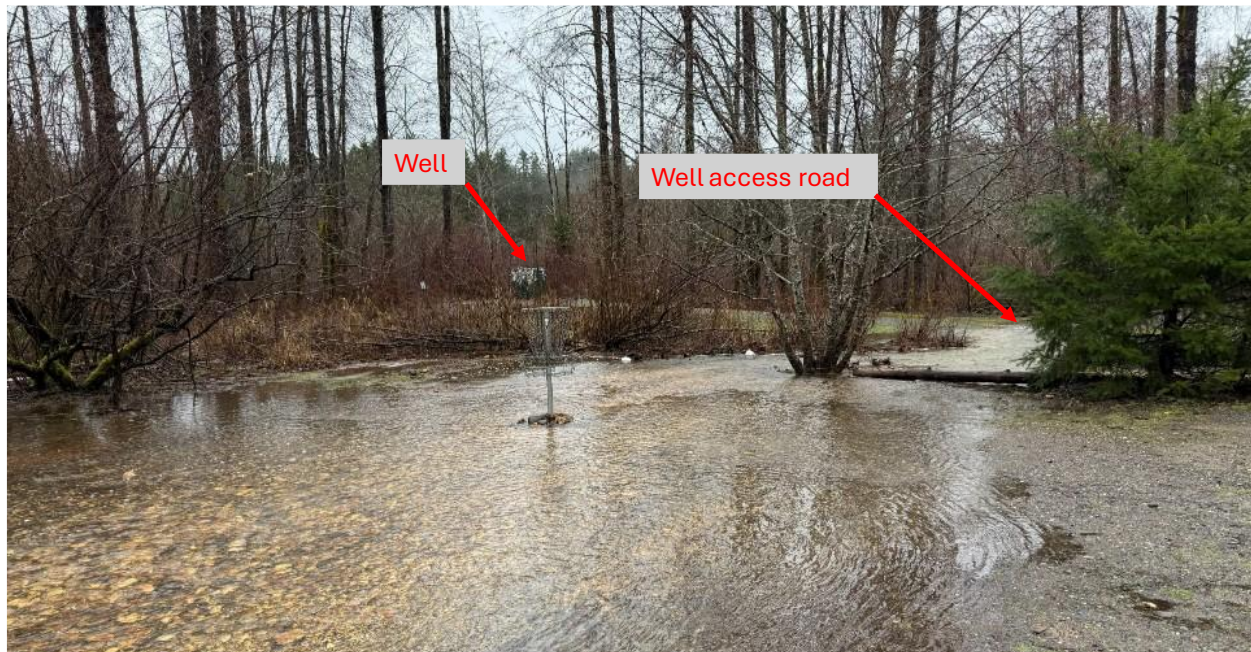
**Figure 1.3** Looking downstream along avulsion channel in disc golf course on February 1, 2026, showing groundwater drinking water supply well and flooded access road for it. Photo courtesy of Adam Silverstein.

- The same information used to assess Risk to the well was used to assess Risk to the well access.
- Hazards: high (4) in winter, low (2) in summer
  - Water was observed flowing along access during January 30 event (Figure 1.3, pers. comm. David Dougherty June 10, 2026). There have been no mitigation measures put in place for this yet, so there is nothing from preventing it from occurring again once flows increase.

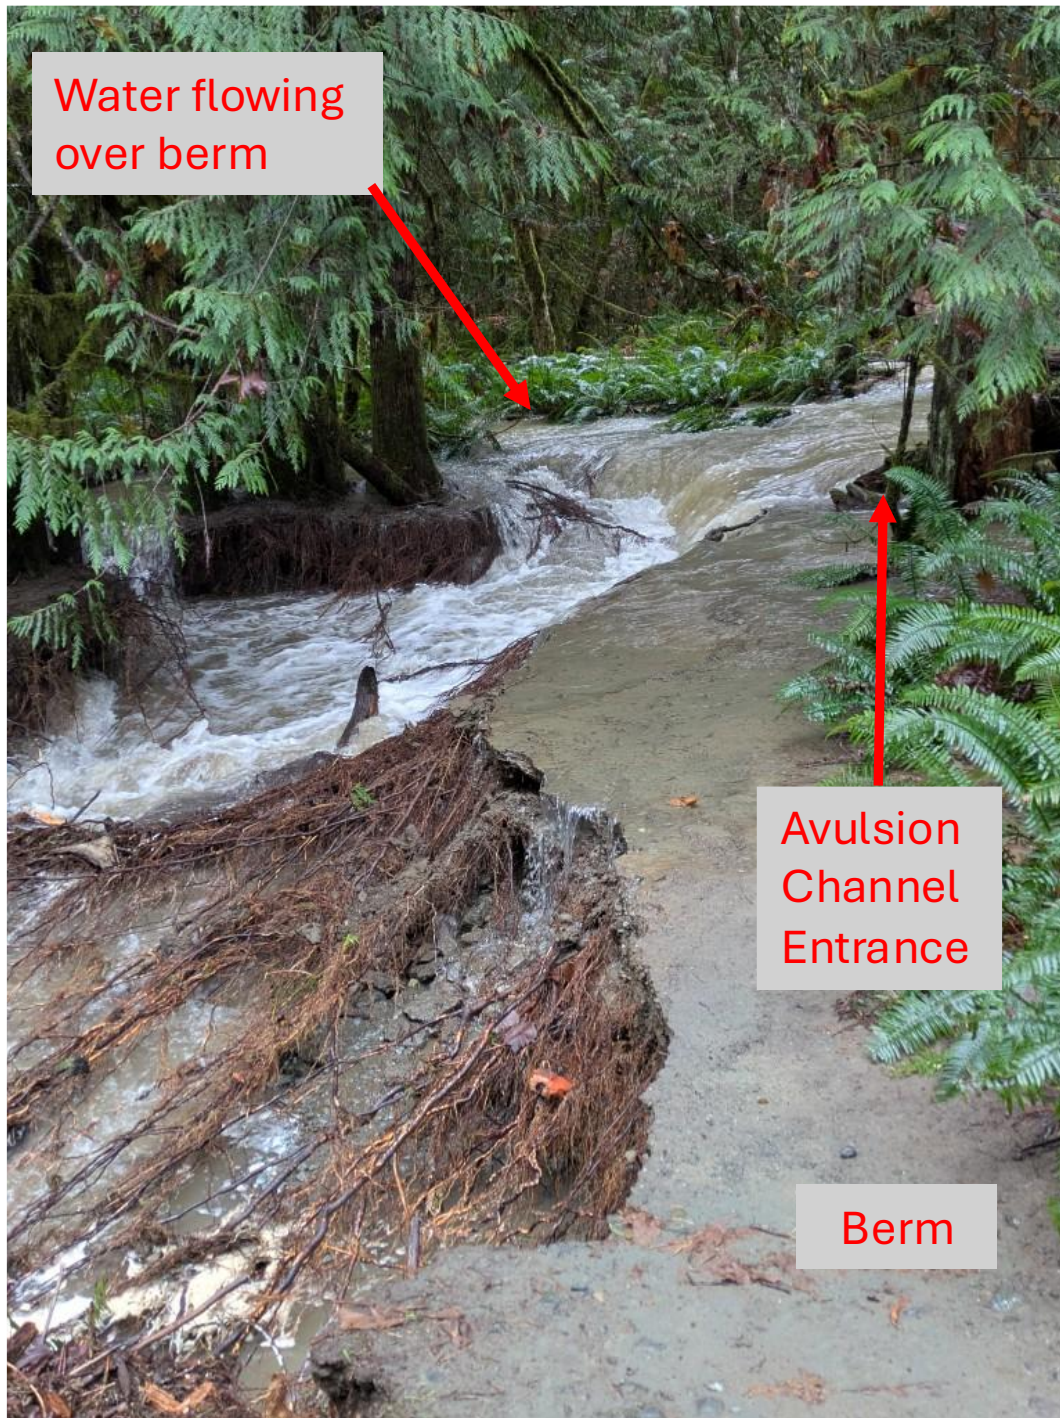
Photos from January 30 show water flowing over the berm into the avulsion channel (Figure 3.4). There is also a small entrance to the avulsion channel under the river right bridge abutment that diverts a portion of the flow from Perseverance Creek (Figure 3.5, Figure 3.6, Figure 3.7). This entrance is at a lower elevation than the main channel bed, has a smaller cross-sectional area than the main channel, and has a log jam between it and the main channel. While the lower entrance means water will flow into the avulsion channel before the mainstem, its small cross-sectional area suggests that as flows increase, an increasing proportion of the water will flow down the main Perseverance Creek channel, until flows become high enough where water can flow over the berm again. This presents trade-offs when considering whether to remove the jam, which are discussed in 4.2.1.

**Figure 3.4** Looking upstream at avulsion channel entrance on January 30, 2026. Photo by Heather Mathers (Perseverance Creek Streamkeeper).

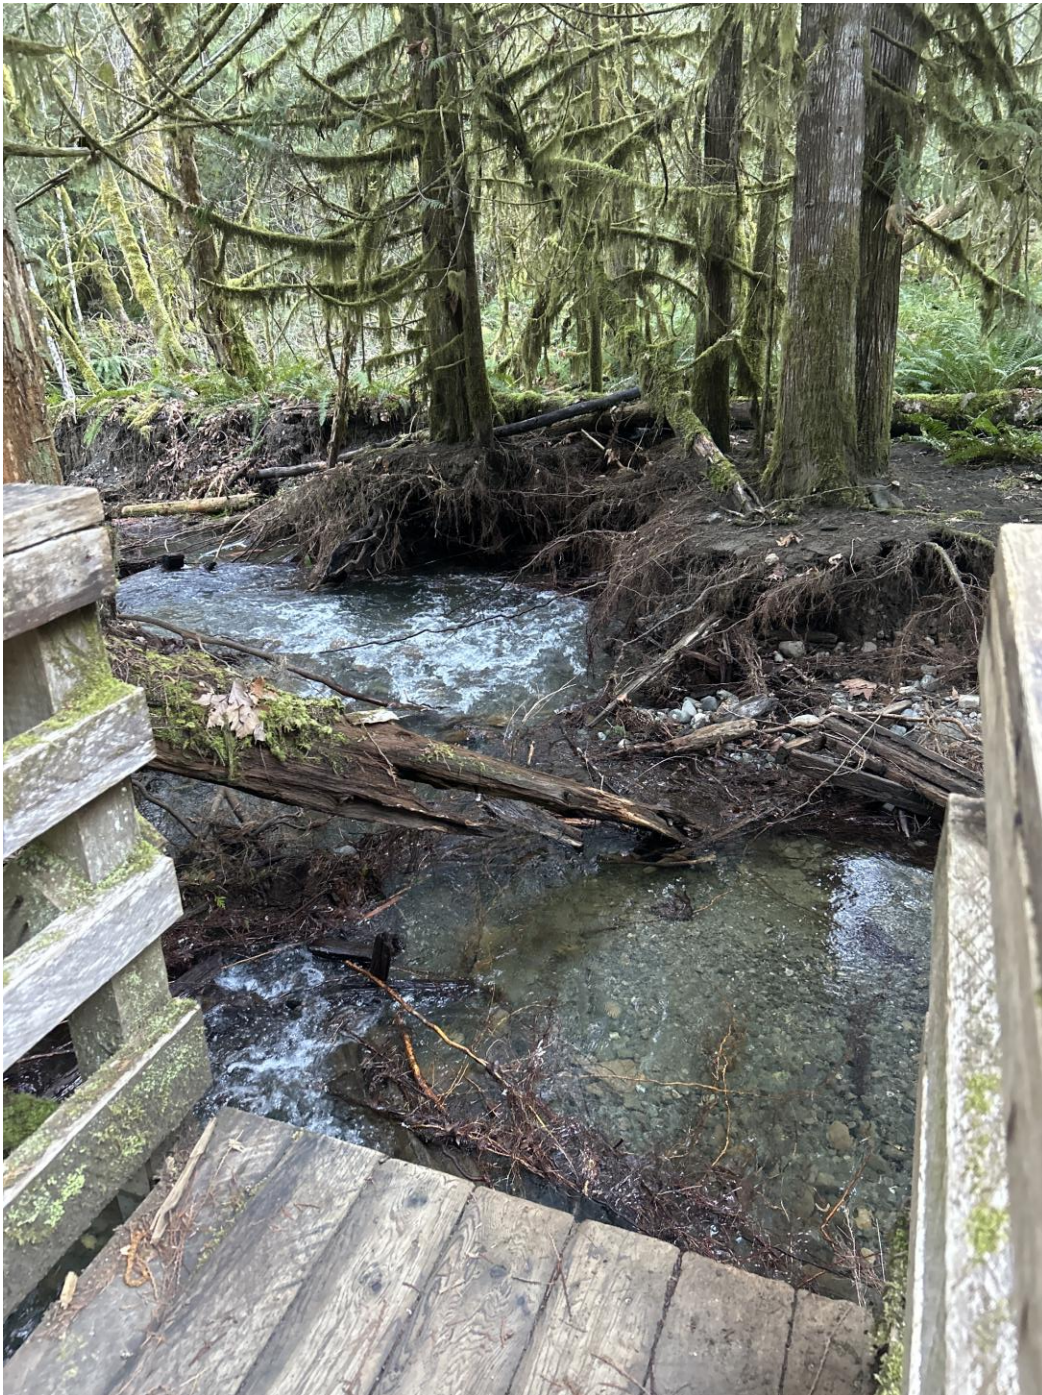
**Figure 3.5** Photograph looking downstream at the avulsion channel on April 7, 2026, showing water flowing into the channel from below the bridge.

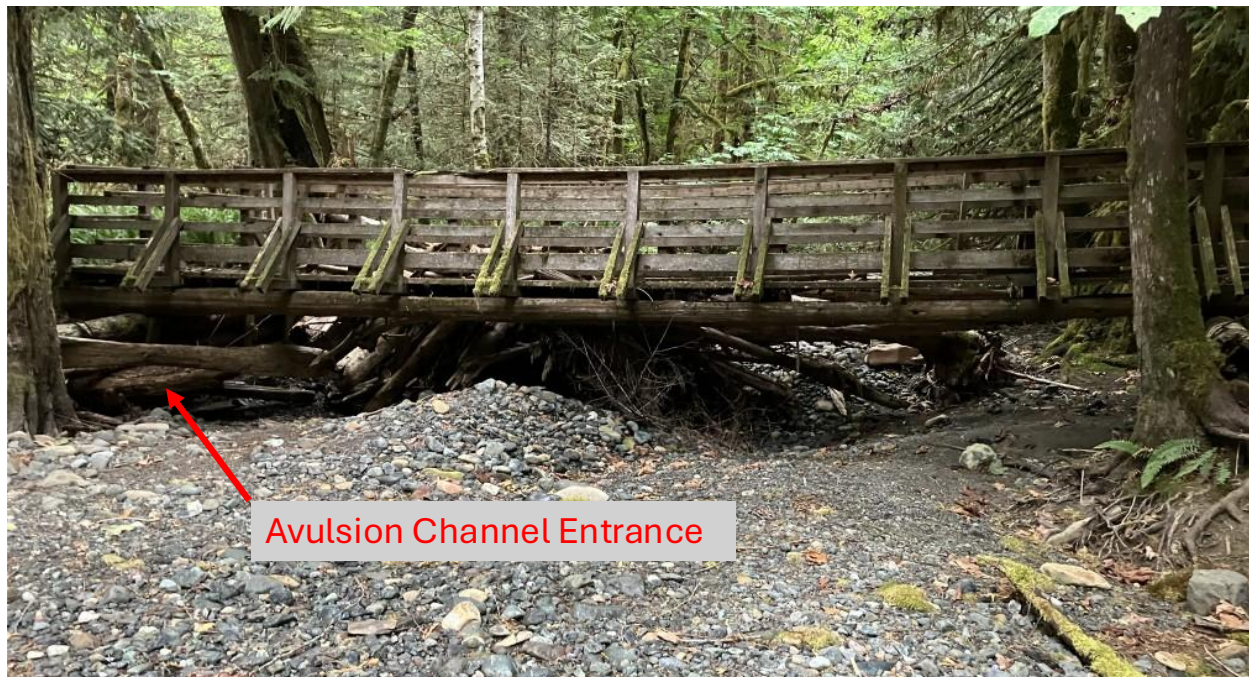
**Figure 3.6** Looking upstream at the downstream side of trail bridge. Log jam on upstream side of bridge. Avulsion channel entrance as annotated. Photo taken July 16, 2026.

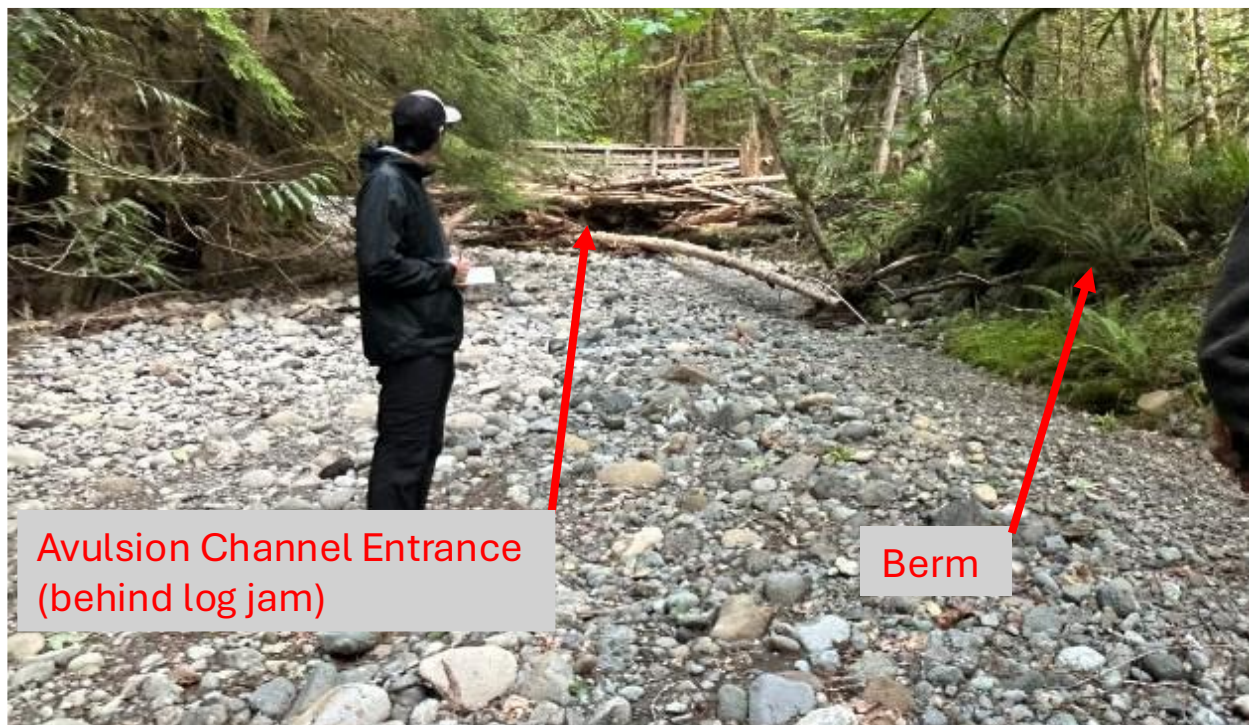
**Figure 3.7** Looking downstream at trail bridge and log jam accumulated on it. Photo taken June 10, 2026.
