# Perseverance Creek Flood Risk Assessment

## Options Analysis and Class 1 Risk Assessment

Final Report, Rev. 1

#### **Village of Cumberland**

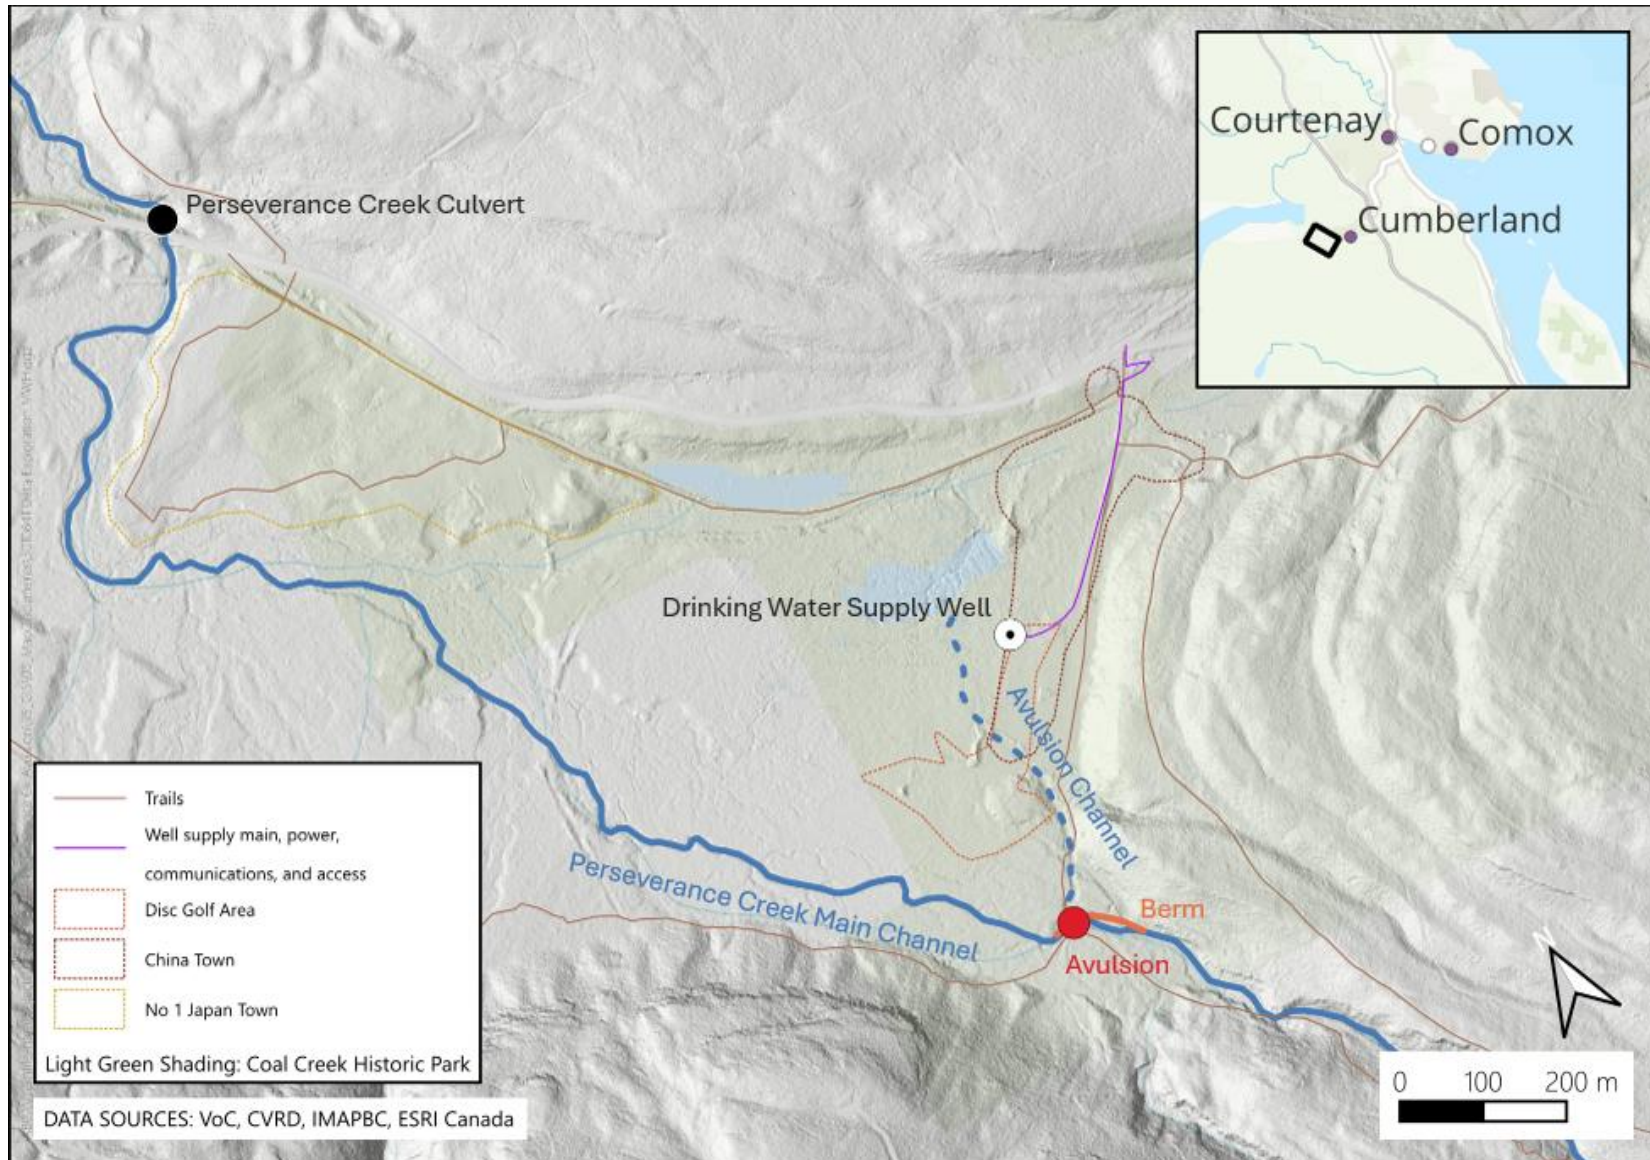
**Figure 1.4** Map showing avulsion location and nearby infrastructure.

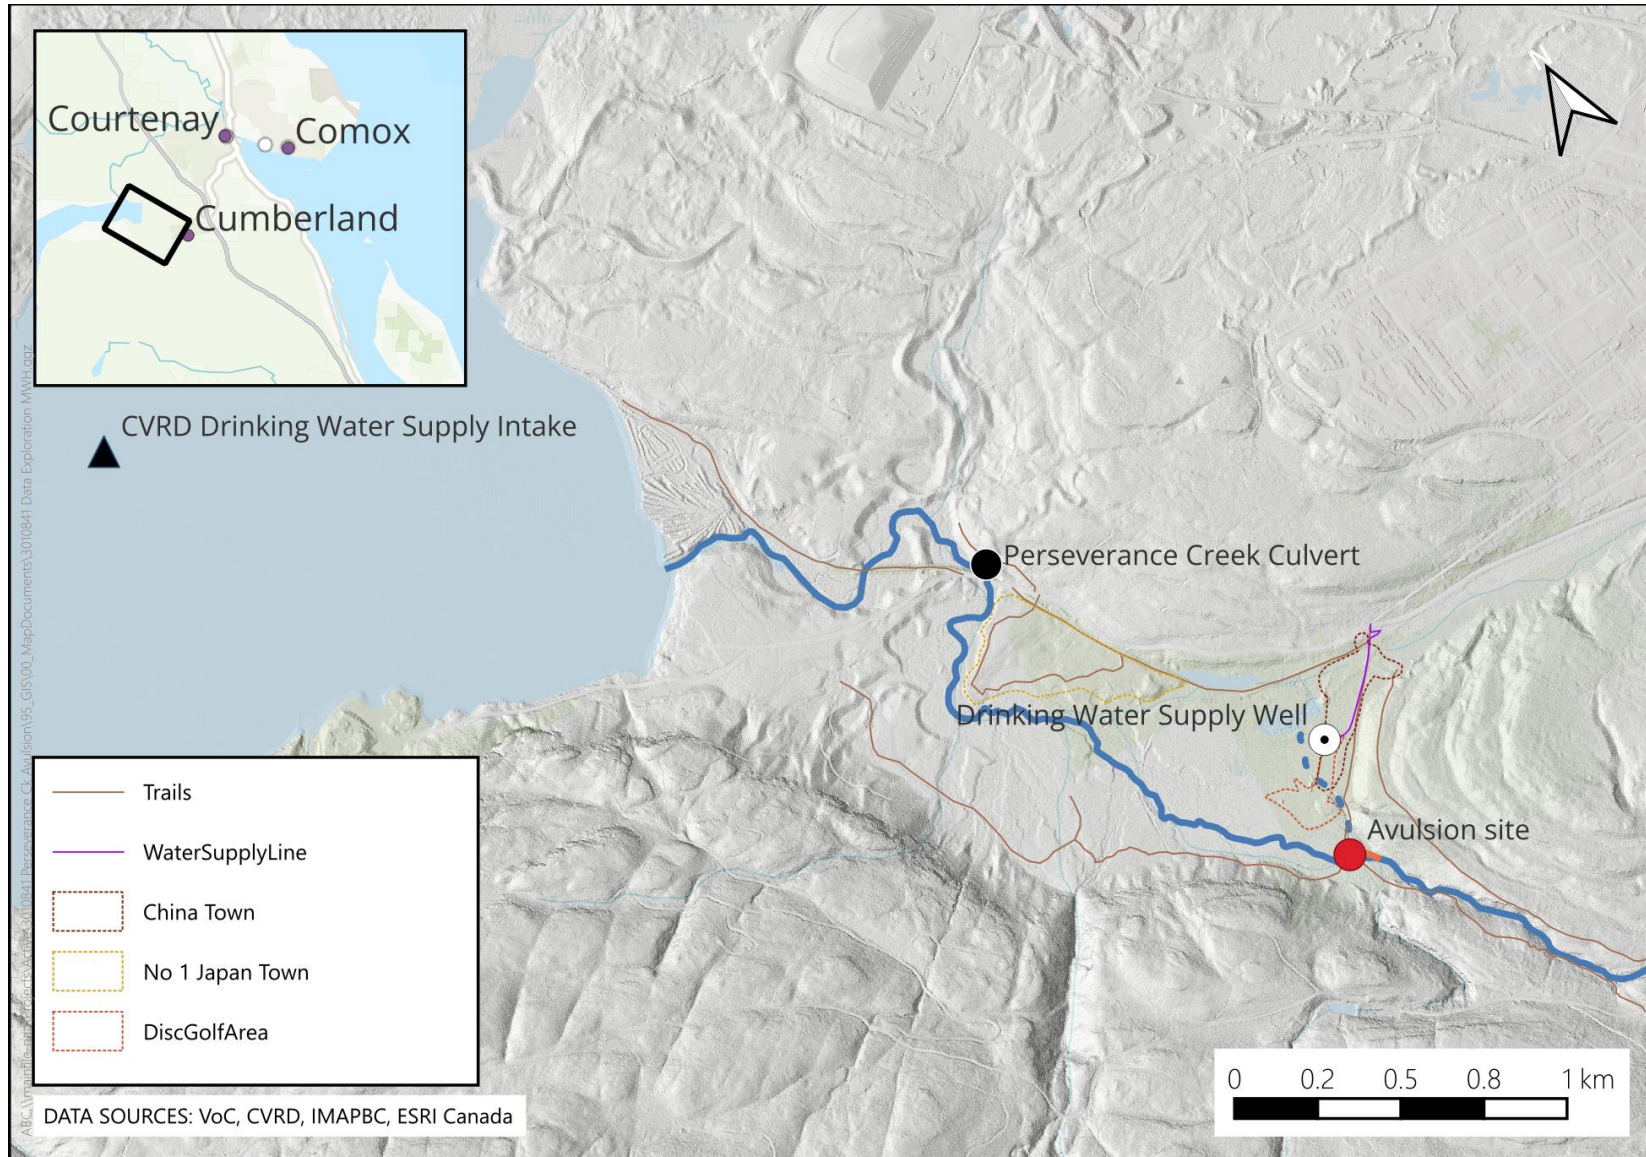
Figure 3.1, Figure 3.2 and Figure 3.3 show these elements in relation to the January 30, 2026 avulsion site at sequentially finer scales. Figure 3.2 and Figure 3.3 include structures that control water levels or direct the creek (hydraulic control structures).

**Figure 3.1 Overview map showing elements considered in risk assessment.**

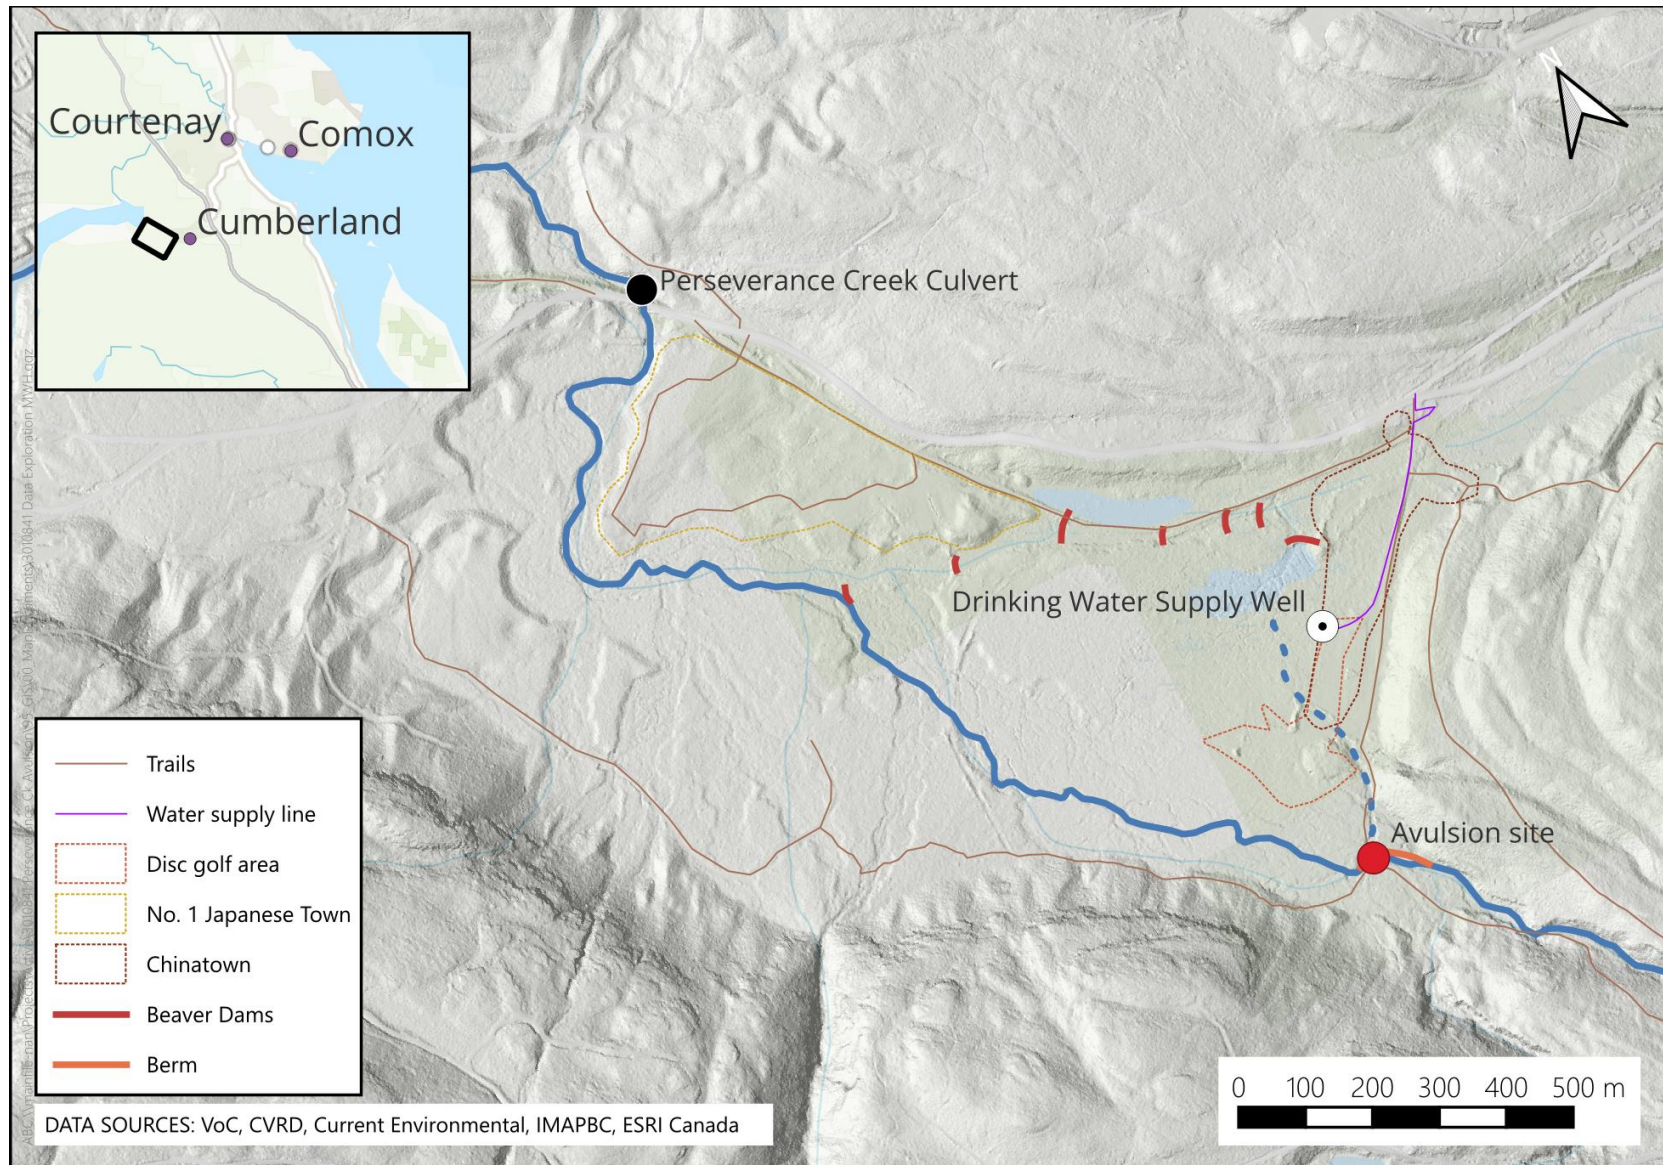
**Figure 3.2** Closer view of avulsion site, elements, and hydraulic control structures in study area.

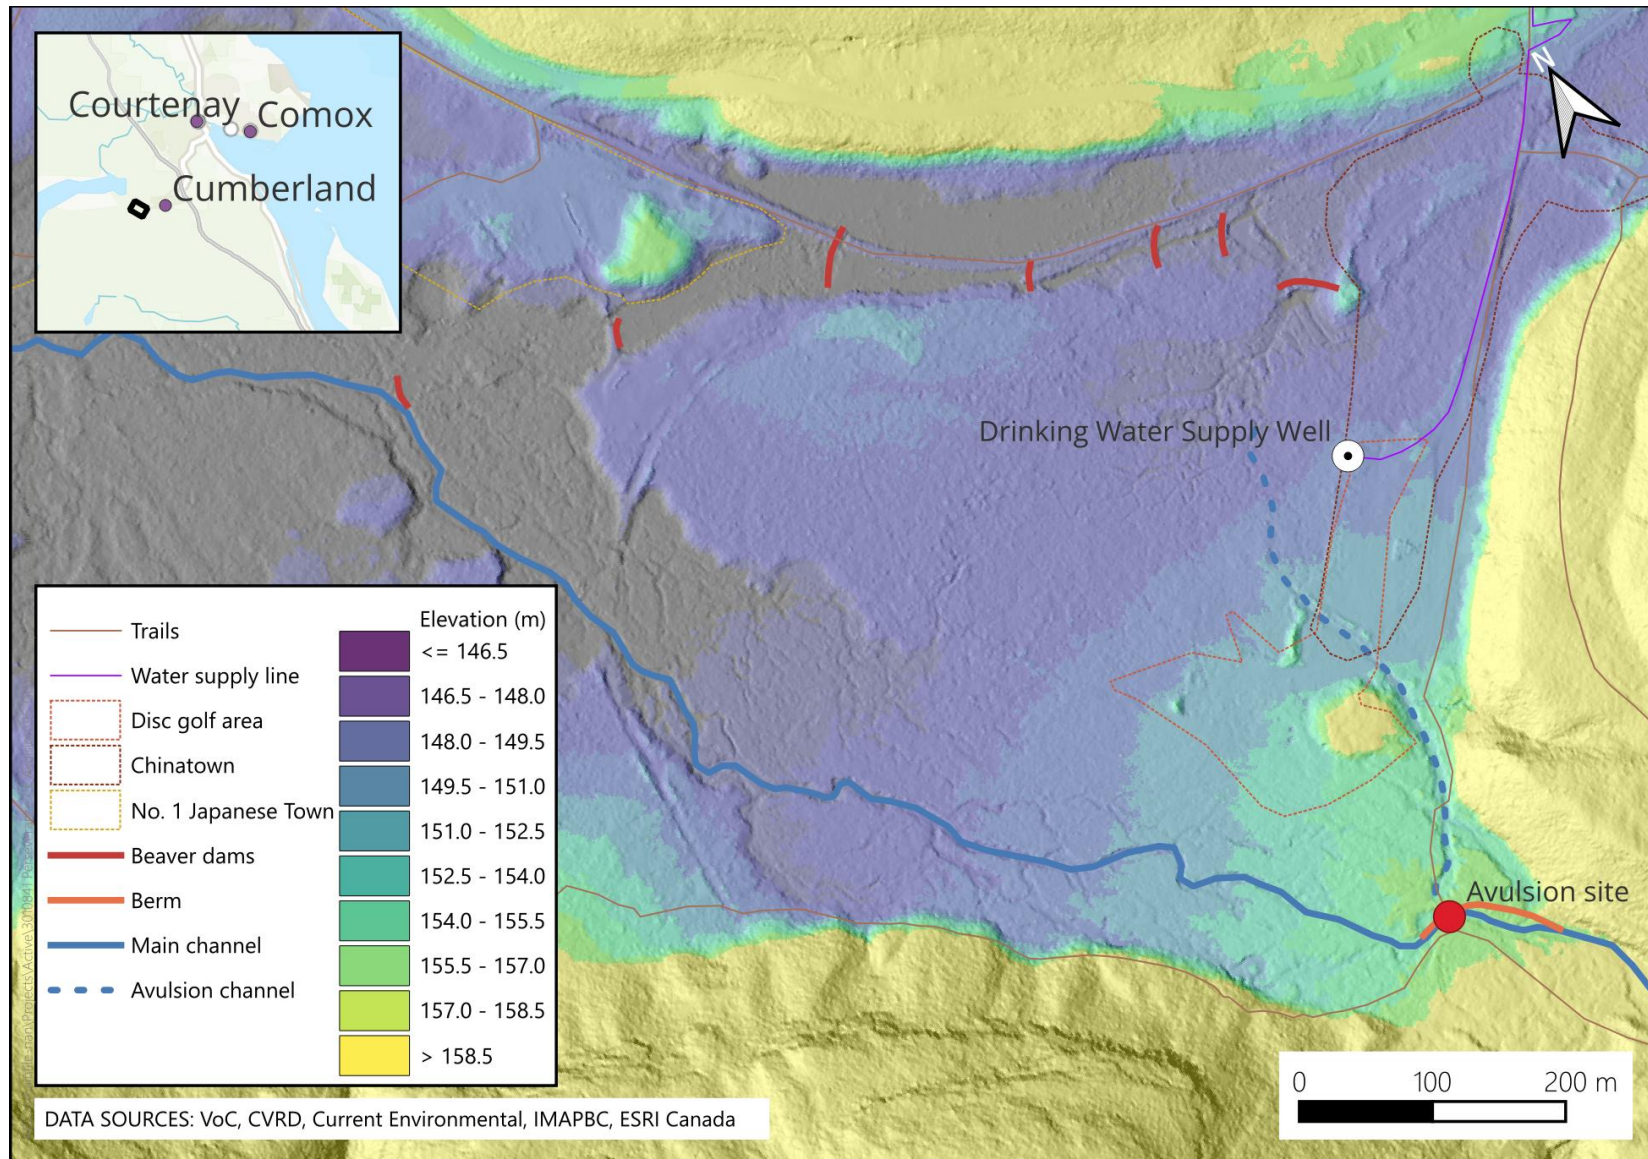
**Figure 3.3** Map showing avulsion site and elements within alluvial fan, illustrated by elevations based on CVRD Lidar.

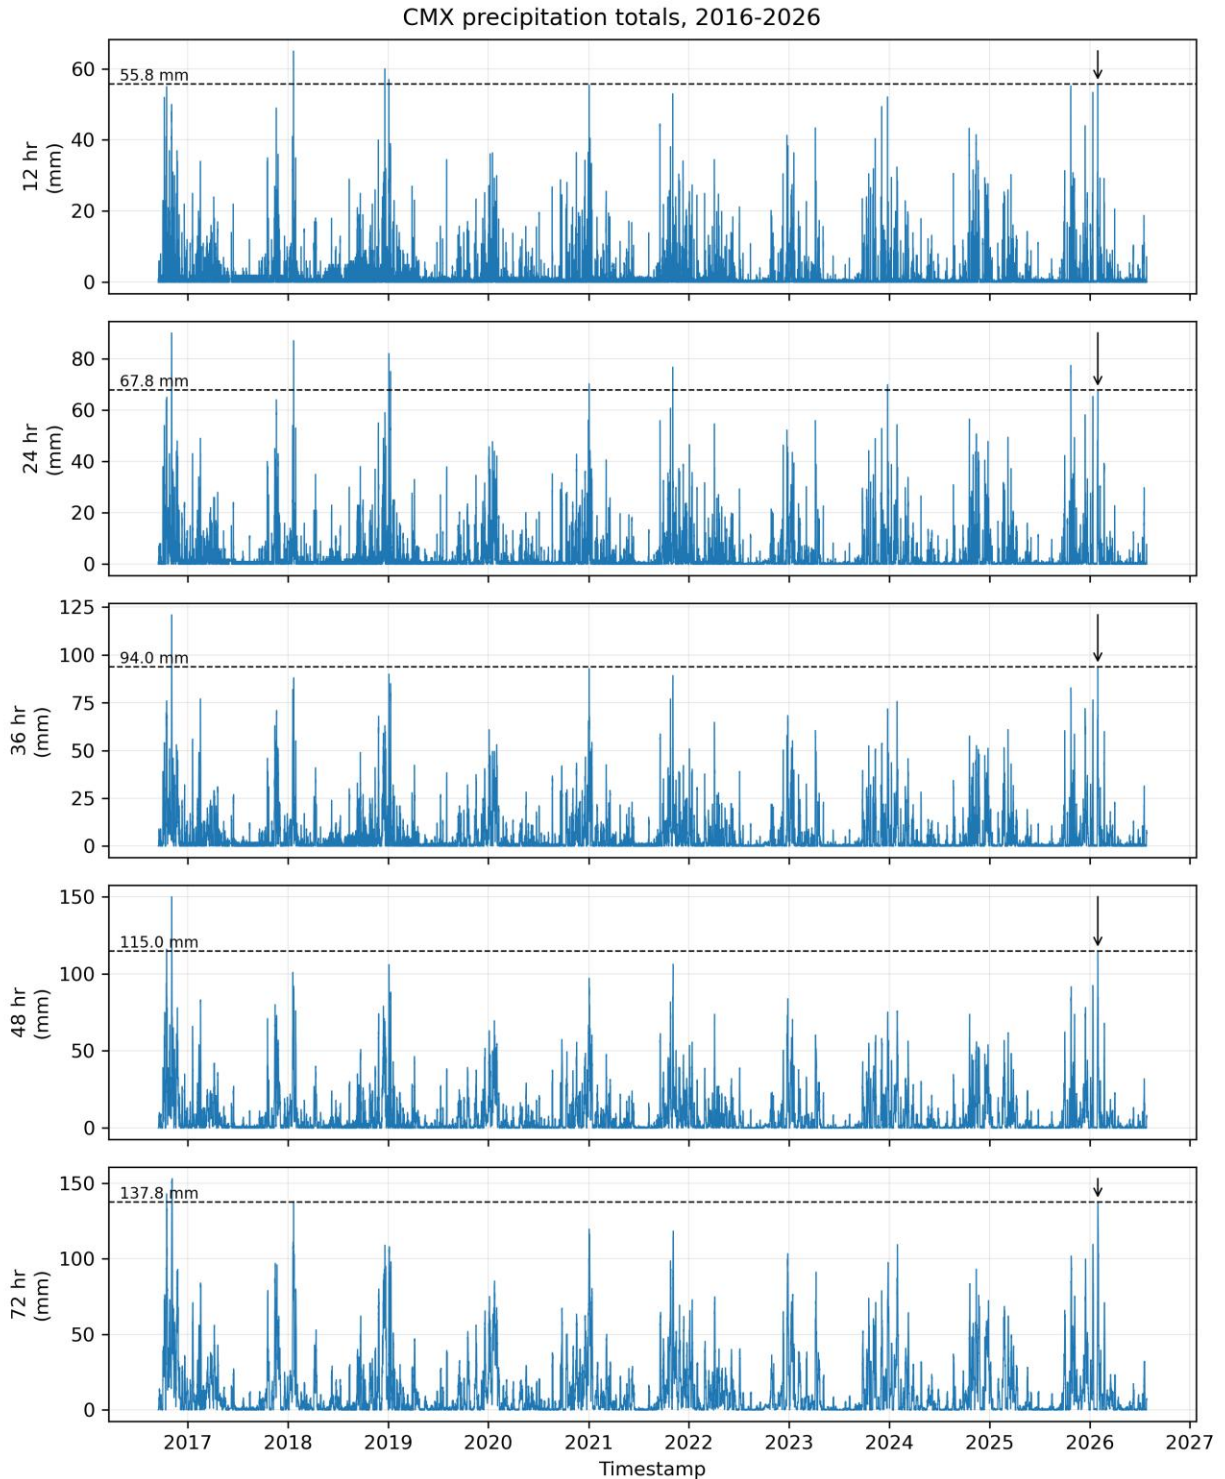
Comparison of the values in Table 3.1 with 12, 24, 36, 48, and 72 hr precipitation totals at CMX since the winter of 2016-2017 provides context for how the January 30 storm event compared to historic storms (Figure 3.8). The 12 and 24 hr totals observed during the January 30 event have been observed in at least half of the years since the winter of 2016-2017. The longer duration totals stood out more, but have still been observed several times: twice for the 36 and 48 hr totals, and three times for the 72 hr total<sup>2</sup>. This suggests that the January 30 storm was significant but not unprecedented; it is within the range of expected winter conditions.

**Figure 3.8** 12, 24, 36, and 48 hour precipitation totals at BC Hydro's Comox Dam Forebay station. Arrows indicate the January 30, 2026 avulsion, with the dashed lines indicating the precipitation totals from that event.

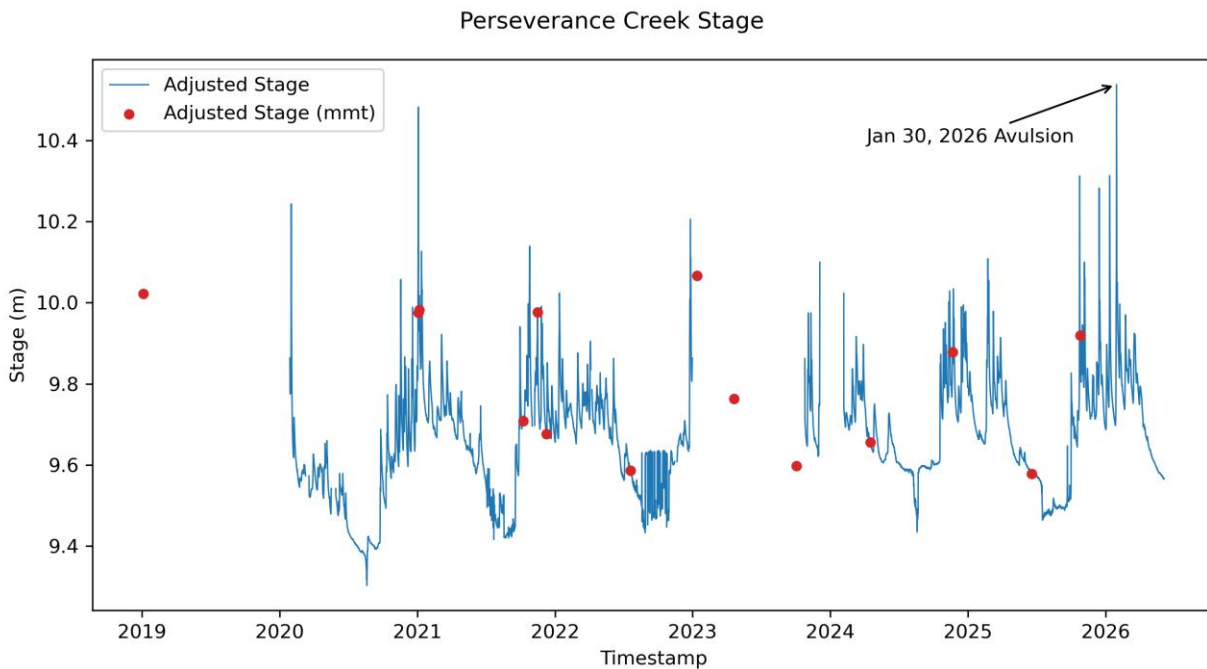
The Comox Valley Regional District (CVRD) has operated a hydrometric station on Perseverance Creek at the Davis Lake Main Forest Service Road crossing since 2020. Preliminary stage data (water level relative to an arbitrary reference datum) are shown in Figure 3.9, with the January 30 event annotated. While the data are preliminary and uncorrected, there are two takeaways:

2. Stage values during summer low flow conditions were approximately 0.1 m lower in 2021 and 2022 than they have been since. Hydrometric reports made available for this assessment state the creek dries up each summer. Stage values during summer low flow conditions are therefore measuring the channel bed elevation. The 0.1 m rise over the data record suggests 0.1 m of aggradation under the water level sensor, illustrating that sediment transport occurring in Perseverance Creek.

While the hydrometric data are preliminary, they support the same general conclusion as the precipitation data: the January 30 event was large, but within the range of observed recent historical conditions.

**Figure 3.9 Stage data at the Perseverance Creek hydrometric station, from 2020-2026**
